Manhole Inspection Summary

Manhole # S23K__006MH

Insp Date: **6/12/08 8:50 AM**

Location Address: **201 S Calhoun St**

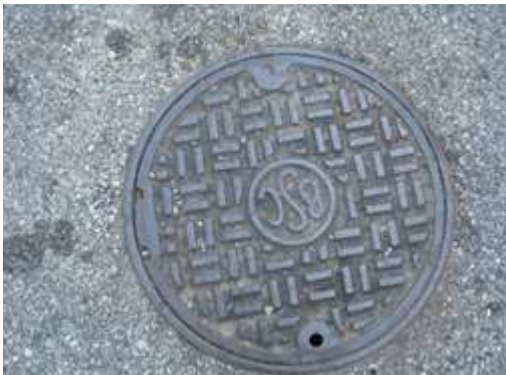
Cover View

Condition: **Worn**

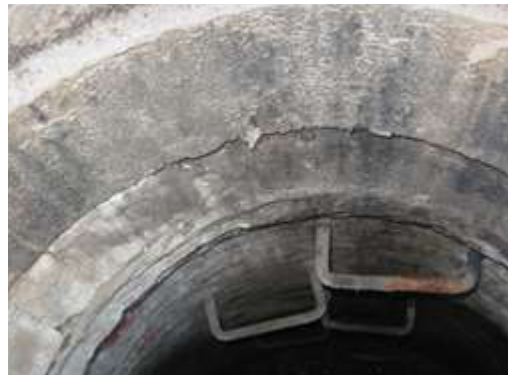
Defect 6

Condition: ☐ Sound ☐ Cracked ☒ **Leaks**

infiltration chimney, frame-lid

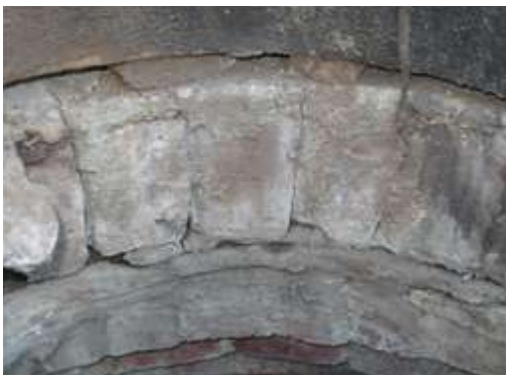
Defect 5

cracked broken mortar

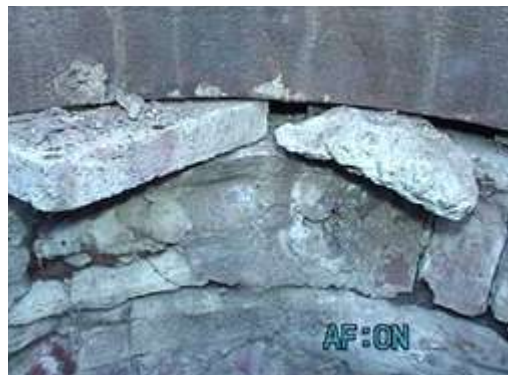
Defect 4

Condition: ☐ Sound ☒ **Cracked** ☐ Root Intrusion ☒ **Loose Brick** ☐ Deteriorated

Infiltration: ☐ None ☐ Joint ☒ **Cracks** ☒ **Mortar** ☐ Roots ☐ Wall

loose bricks , missing mortar, cracked brics chimney

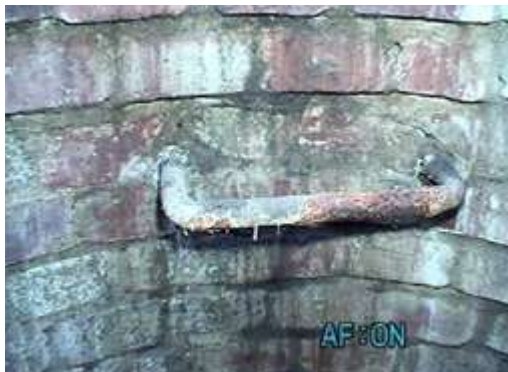
Defect 2

Count: **5** Missing: **0** ☒ **Corroded**

oxidized rungs

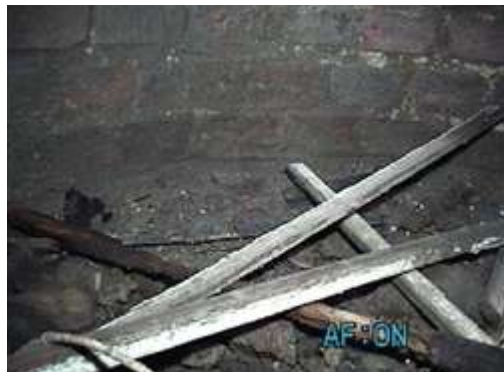
Defect 1

Condition: ☐ Sound ☐ Cracked ☐ Root Intrusion ☐ Deteriorated ☐ Leaks ☒ **Debris**

debris in bench as well as channel

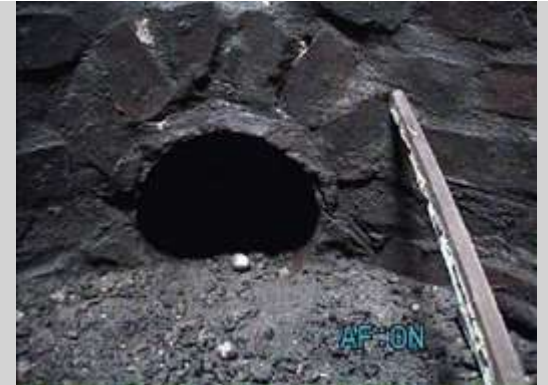
12 O'Clock Outflow

Infiltration: **None** Pipe Seal Cond: **Sound**
